EXPLORATORY CORROSION TESTS IN THE CANADIAN ARCTIC

G.J. Biefer

MARCH 1977

MINERALS RESEARCH PROGRAM
PHYSICAL METALLURGY RESEARCH LABORATORIES
CANMET REPORT 77-45

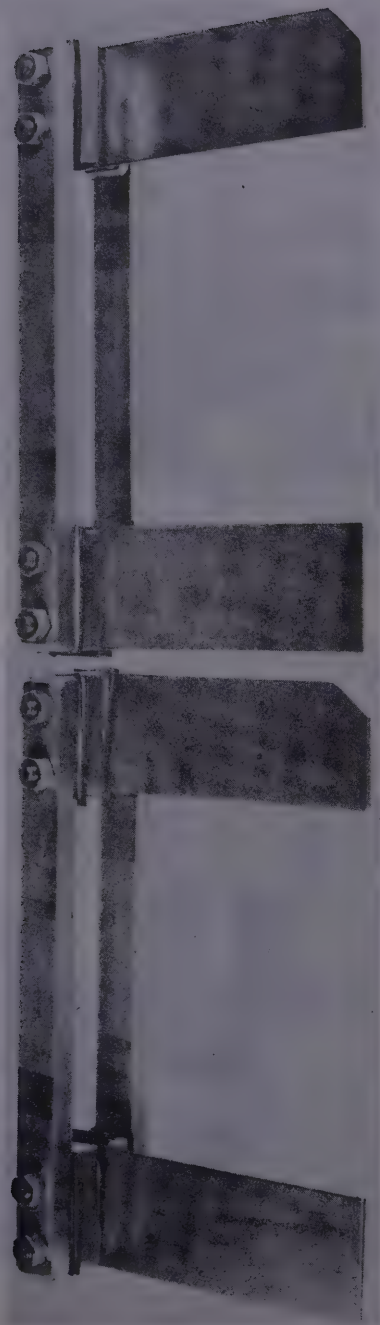
Fig. 1. Specimens in racks prior to sea-water test at Musquash Harbour, N.B.
X 1/3

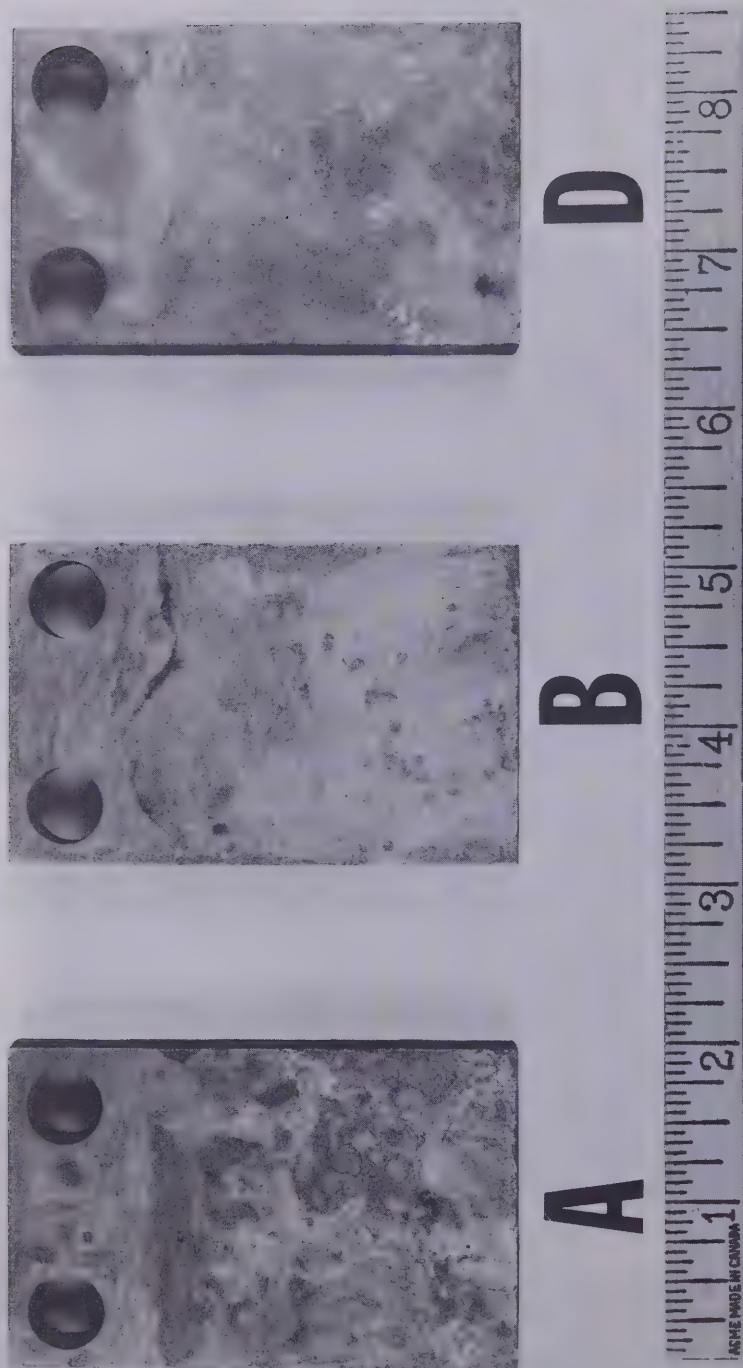
Subsequent to de-rusting in inhibited acid, weight losses by corrosion were shown to be those in Table 2. Specimen surfaces were relatively smooth, with only large, shallow pits and etched areas to be seen (Fig. 8). The depths of some of these were measured relative to the very lightly corroded rim which had been in contact with a plexiglass backing. The maximum depths thus measured (not necessarily the deepest penetrations) are shown in Table 2.

X-ray diffraction analyses of the corrosion products were performed at PMRL. The thick layers of red rust were found to consist of a mixture of α FeOOH (goethite) and γ FeOOH (lepidocrocite). Corrosion product from the dense, shiny purple-brown layers contained the same constituents and a minor quantity of Fe_3O_4 (magnetite).

Fig. 8. De-rusted specimens after 1 year in sea water at Devon Island, N.W.T.

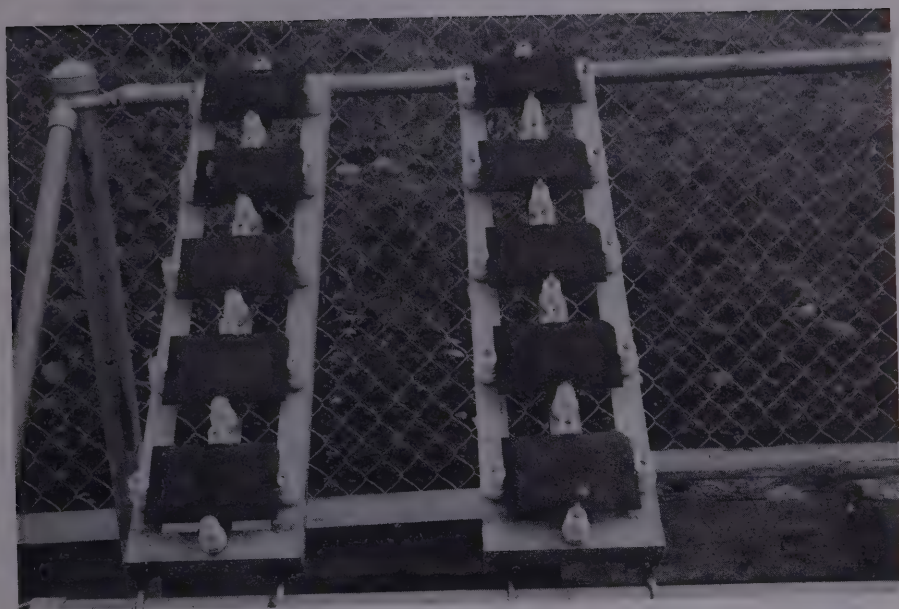
After exposure to the atmosphere at Tuktoyaktuk for one year, the structural steel specimens showed rusty surfaces, as did all uncoated steel nuts, bolts, etc., used in the construction of the compound and the racks. The galvanized steel was in excellent condition except for minor staining at a few places. These features can be seen in Fig. 9, showing the specimens after exposure for one year at Tuktoyaktuk. Very little additional corrosion appeared to have occurred after three years exposure.

Both the one-year and the three-year sets of specimens exhibited tightly adherent rust coatings. De-rusting in inhibited acid showed the light, shallow pitting usually seen in atmospheric corrosion attack, complicated by the presence of angular indentations produced by the grit blasting. Weight losses are shown in Table 3.

Fig. 9. Specimens of structural steel after one-year's exposure at Tuktoyaktuk, N.W.T.

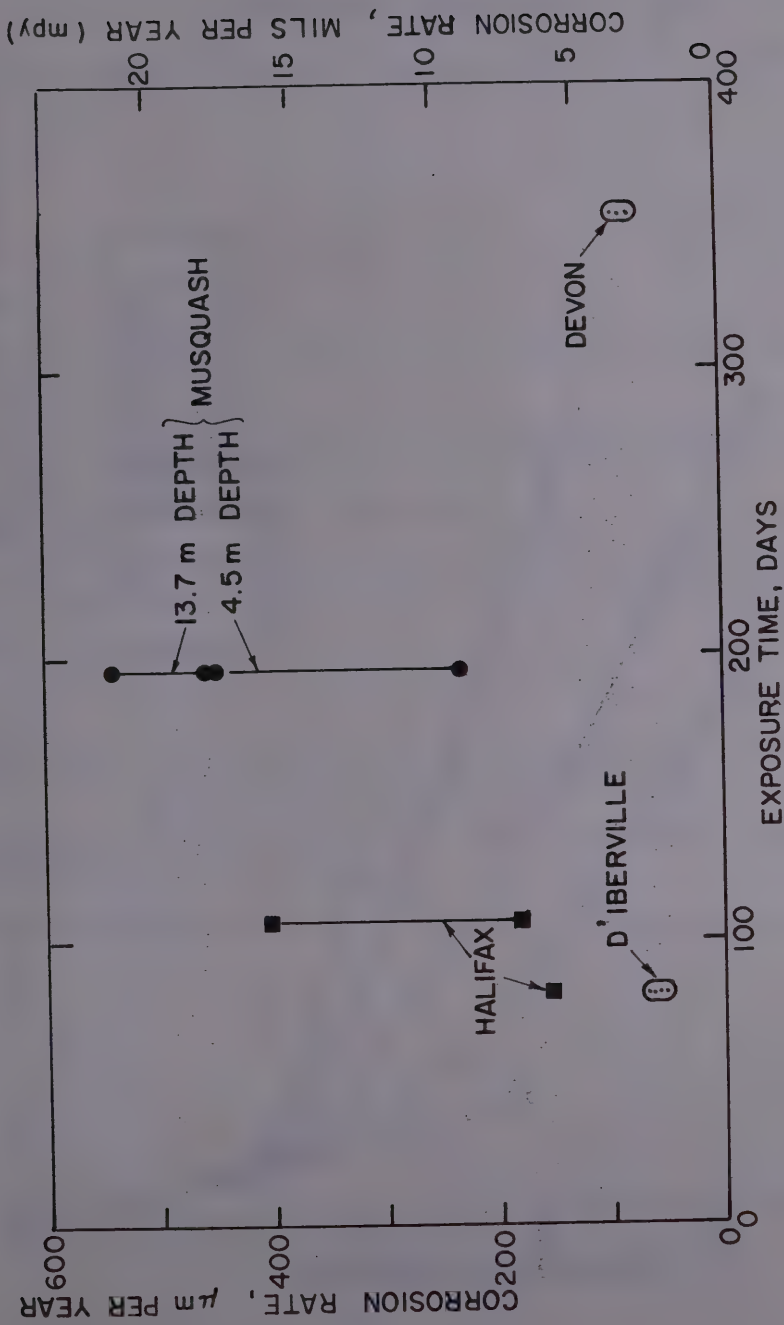
Steels in low-velocity sea water generally show their most rapid corrosion rates immediately after immersion; there is then a decline in the corrosion rate which may approach a steady state, usually after a year or more on test(1). This is illustrated by the results reproduced in Fig. 10.

Fig. 10. Figures extracted from reference (1), showing sea-water corrosion rates as a function of exposure time (1 mil = 25.4 μ m).

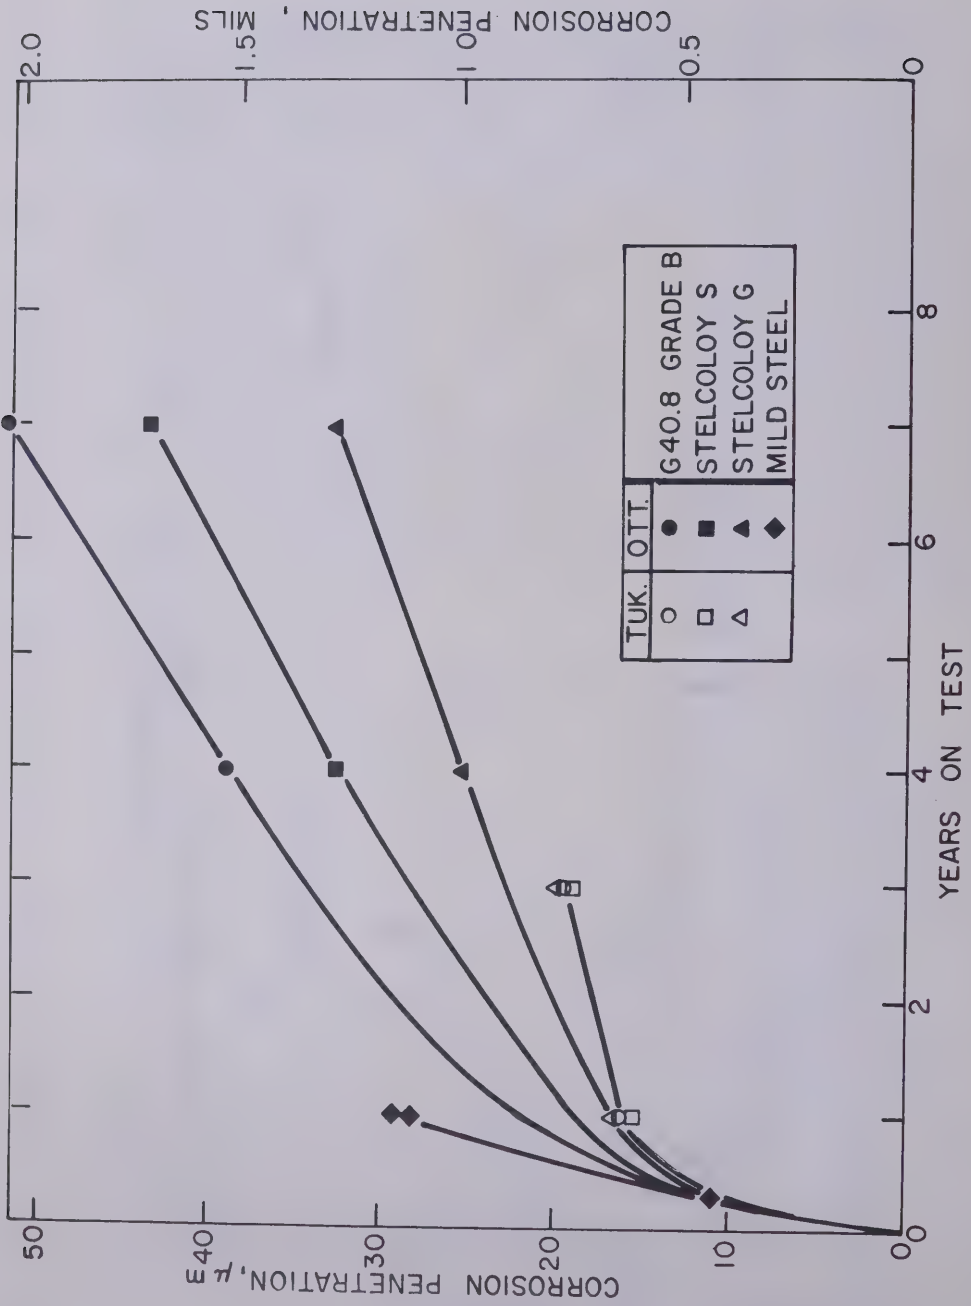
Corrosion rates for each specimen are plotted versus exposure time (Fig. 11). It can be seen that corrosion rates in the Arctic tests are considerably lower than those observed in Maritime waters. Comparison with the data in Fig. 10 suggests that corrosion rates in Maritime waters are somewhat higher than those generally observed at the surface of the Atlantic and Pacific oceans. The corrosion rates observed in the Arctic, on the other hand, resemble those obtained in deep sea water, with d'Iberville Fiord providing the least corrosive conditions of the four test locations.

Fig. 11. Average corrosion rates of carbon and alloy steels in the sea-water tests.
